RADIO KEYLINE MODIFICATION

SCOPE: This modification applies to all Sigtronics intercom (SPA-, SDB-, SCI-, Sport-) installations that will utilize both pilot and co-pilot transmit positions. See alternate solution if using pilot only transmit position.

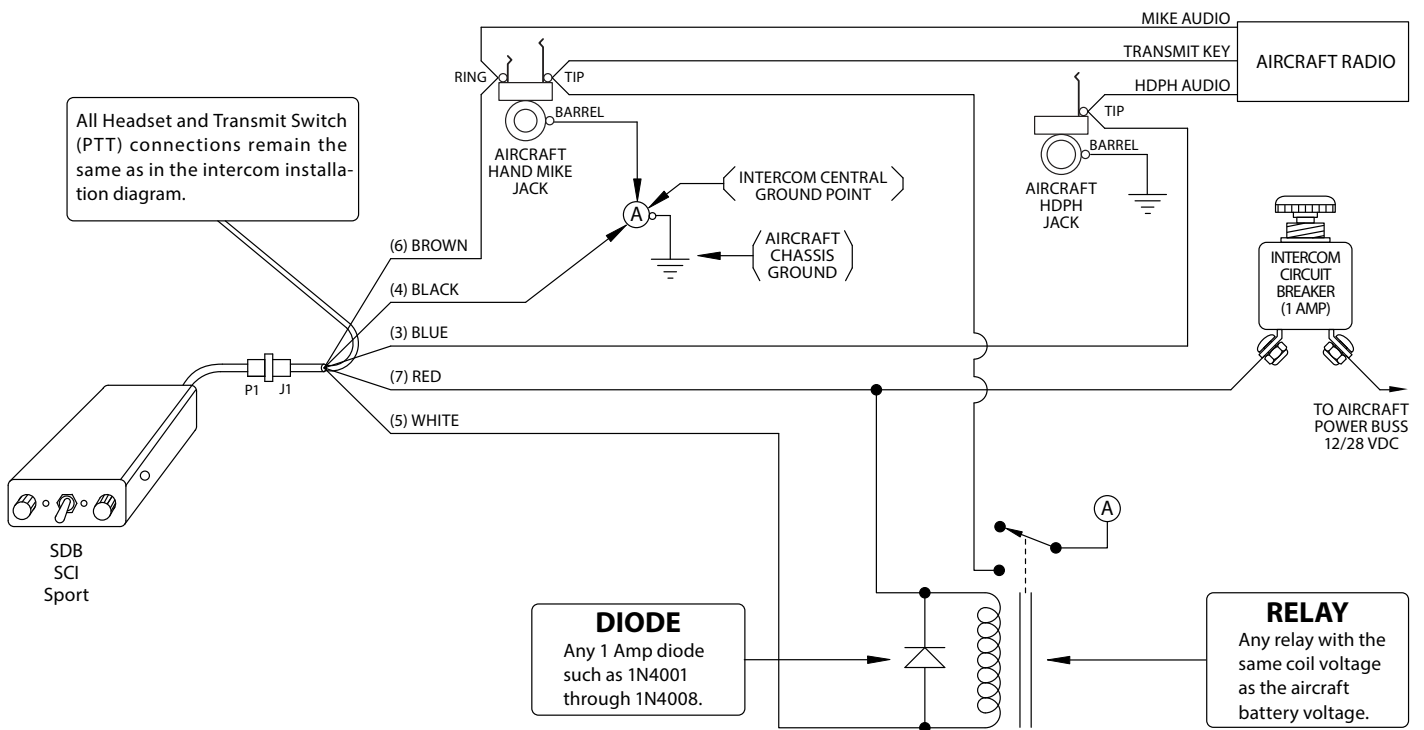
PROBLEM: The radio will not key up when either pilot or co-pilot PTT is pressed. This is due to the 0.7 volt diode drop within the intercom. Common installations affected usually involve KMA-20 audio panels or ICOM A220 radios.

SOLUTION: A relay can be added to the installation that will eliminate the 0.7 volt diode drop. Follow the wiring diagram below.
